# ICON

## Spin-Resistance at ICON Aircraft Raising the Bar for Light Aircraft Safety

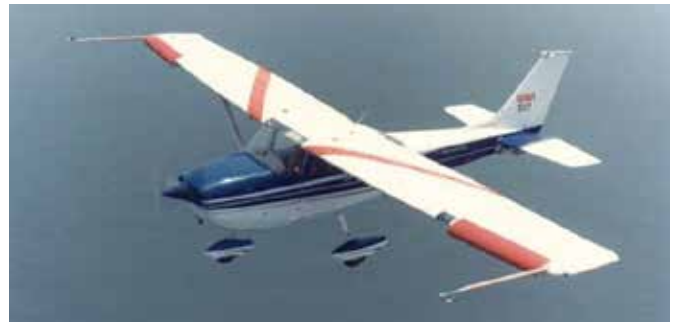
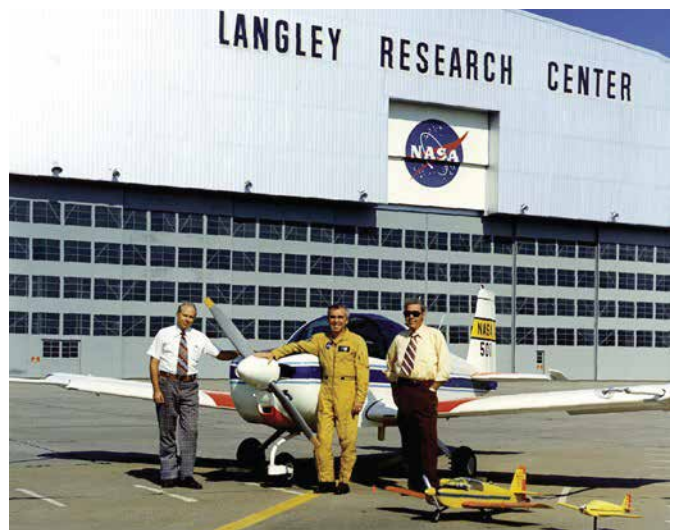
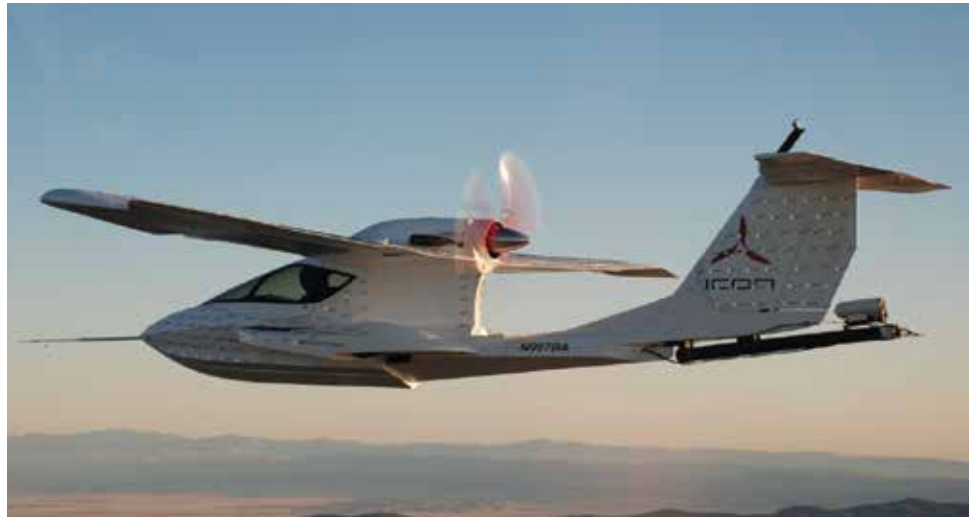
(CLOCKWISE FROM TOP RIGHT)

One of NASA's spin test aircraft, a Cessna 172 equipped with wing cuffs (in red on the leading edge of the outboard parts of the wing), in flight. Credit: NASA

James Patton Jr. (center) stands with James Bowman Jr. (left) and Sanger Burk (right) in front of a low-wing spin research aircraft. A radio-controlled model and a spin-tunnel model of the same configuration are in the foreground. Credit: NASA.

The ERCO Ercoupe is one of the earliest aircraft with spin-resistant characteristics, which were achieved by limiting the deflection of control surfaces (including the elimination of rudder pedals from the cockpit), as well as the location of its center of gravity. Credit: Smithsonian National Air and Space Museum

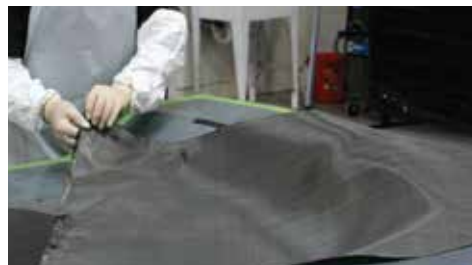
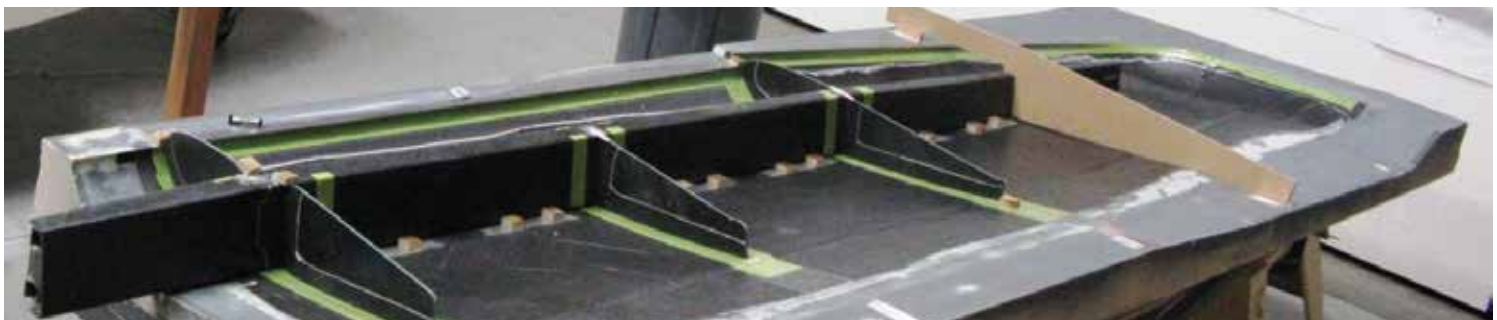
An ICON shop technician prepares sheets of carbon fiber for lamination in the wing mold.

The partially completed spin-resistant wing with main spar and ribs

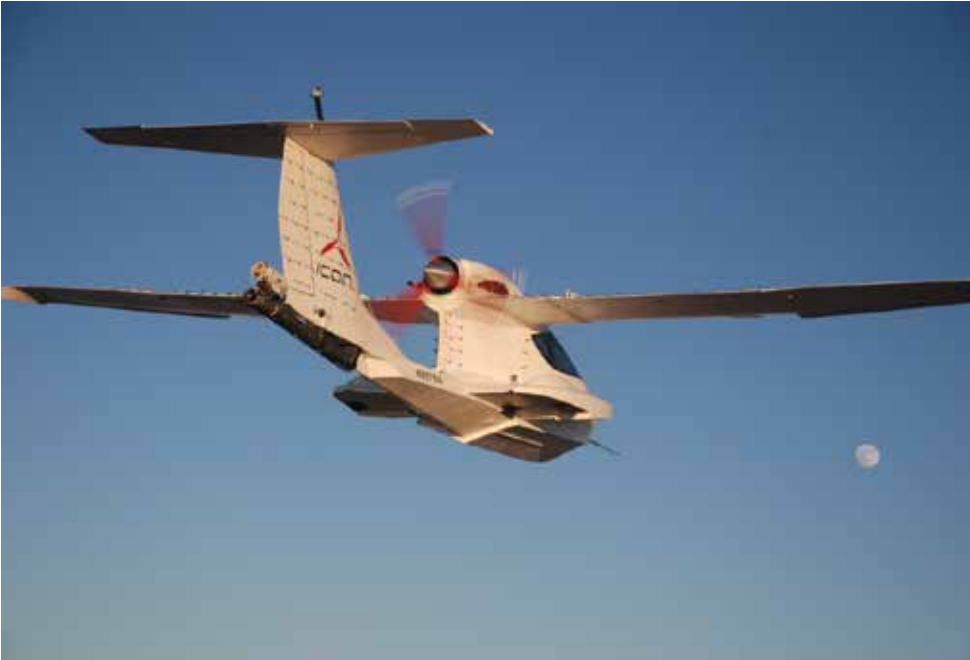
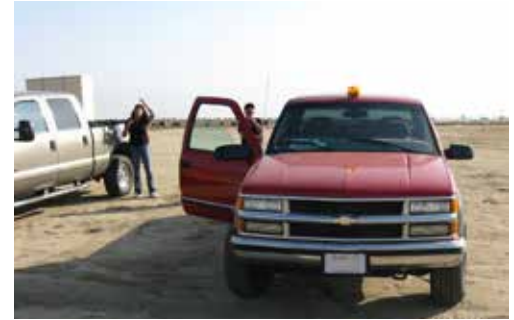
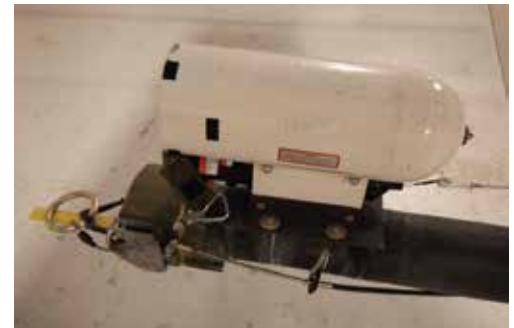
(CLOCKWISE FROM LEFT)

The A5 as equipped for spin-resistance testing with yarn tufts, spin parachute, and GoPro cameras used for data collection.

ICON ground crew looks on as the A5 performs its spin-resistance tests. Their purpose is to recover the spin parachute and/or pilot in the event of a deployment. Fortunately, the parachute never needed to be deployed.

The installed boom-mounted spin parachute

ICON engineers designed, built, and installed a boom to mount the spin parachute on the back of the A5 prototype and also retained globally
